LOCTITE*Adhesives for more
reliable assemblies***APPLICATION CASE HISTORY****No. 212**

Quick Metal® Repairs Gear Box Input Shaft; Saves Paper Mill Million Dollar Shutdown

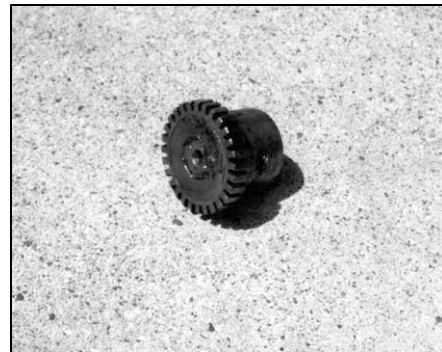
The paper mill experienced a failure of a grid-type coupling hub on the main drive of their coal conveyor. The problem was found to be a wallowed keyway and spinning of the coupling hub on the gearbox input shaft. Since there wasn't a spare gearbox for this conveyor drive in the plant, the maintenance team determined that there were only several operating hours worth of coal left in the bunkers to feed their boilers. After that, the paper machines would be shut down in order to switch over to natural gas.

Coupling hub repaired with Loctite Quick Metal.

As the shaft was worn substantially more than 0.040" diametrically, the millwright decided to make a "Loctite Sandwich" constructed of shim stock and Quick Metal. The coupling hub was then reinstalled.
